Service Bulletin

19-011

January 30, 2019 Version 1

Safety Recall: 2016-18 MDX and 2015-19 TLX V6 Fuel Pump

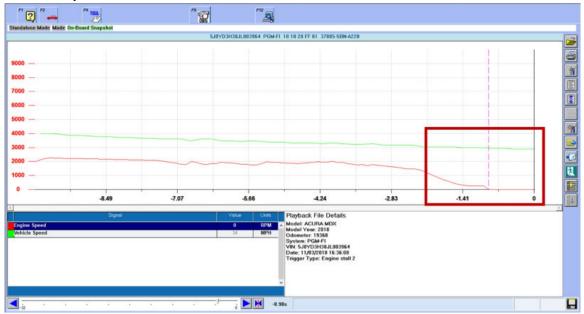
5. Select the Line Graph icon. If **Engine Speed** is 0 RPM while **Vehicle Speed** is greater than 0 MPH, the engine stalled and you must do REPAIR PROCEDURE B - PGM-FI UPDATE AND FUEL PUMP REPLACEMENT.
